**Flood Control Project Maintenance
Levee Inspections**

Spring 2012 Levee Inspection Results

Reclamation District No. 2104 Peters Pocket Tract

Waterway			Bank	Unit Miles
Unit No. 01 Cache Slough			Left	7.40
	Spring (March - May)	Summer (June - August)	(September - November) Fall	Winter (December - February)
Unit Maintenance Rating (Fall Only)				
Date of Inspection	5/2/2012 - 5/2/2012			
DWR Inspector	Herman Phillips			
Accompanied By	Ken Machado RD 2104			
	Chris Niederhauser Chance Land & Livestock

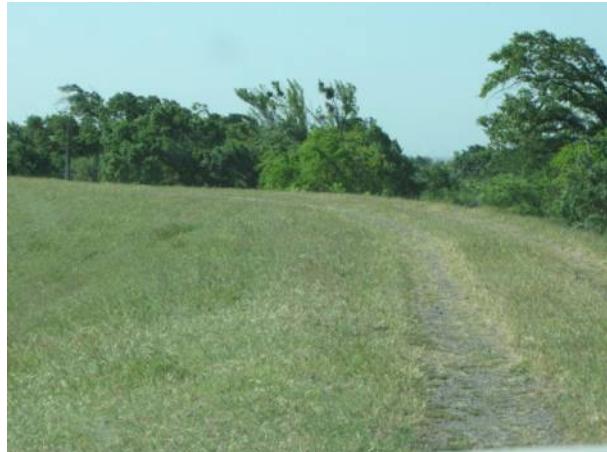
Levee Mile Report Line	3
Start Levee Mile	0.00
End Levee Mile	0.00
Location	Land Side
Category	Earthen Levee
Item	Vegetation

RD 2104 Looking downstream from gate. Photo taken 5-2-2012.

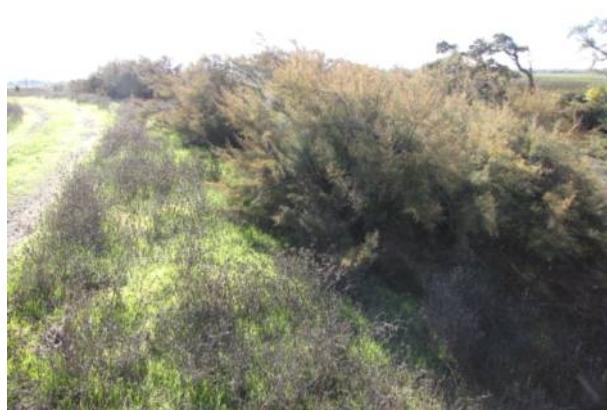
Levee Mile Report Line	6
Start Levee Mile	0.19
End Levee Mile	0.22
Location	Water Side
Category	Earthen Levee
Item	Vegetation

Looking downstream from levee mile 0.19. Soft ceder need to be removed from levee slopes. 11-17-2010

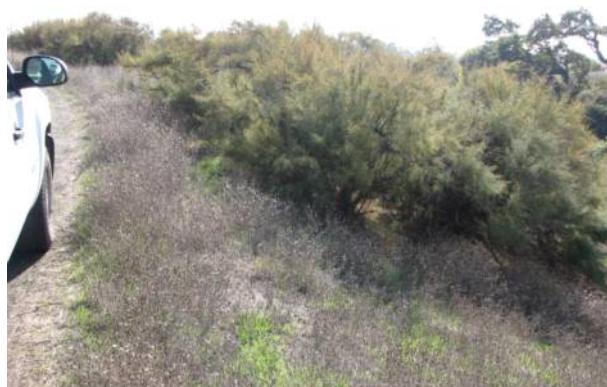
Levee Mile Report Line	6
Start Levee Mile	0.19
End Levee Mile	0.22
Location	Water Side
Category	Earthen Levee
Item	Vegetation

RD 2104 Unsatisfactory wild growth on water ward slope. Photo taken 11-15-2011.

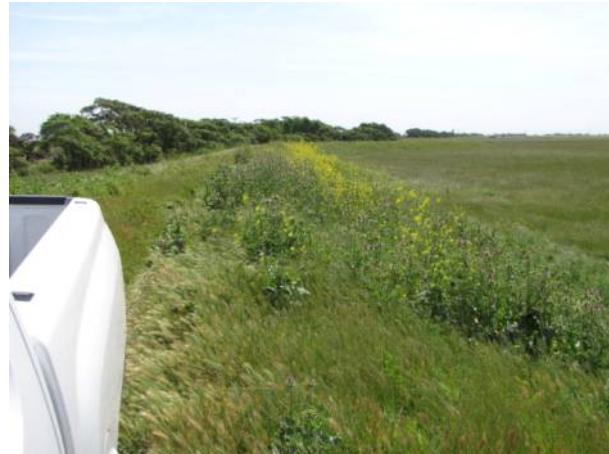
Levee Mile Report Line	22
Start Levee Mile	1.40
End Levee Mile	7.40
Location	Crown
Category	Earthen Levee
Item	Crown Surface / Depressions / Rutting
Over grown crown road way. Photo taken 5-2-2012.	
phillips_s_20120525_481.jpg

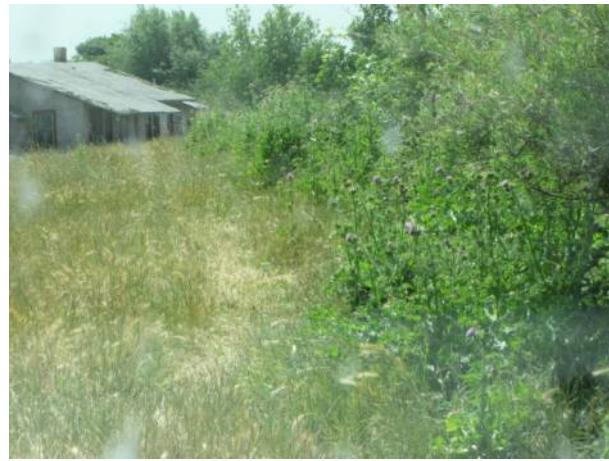
Levee Mile Report Line	24
Start Levee Mile	1.43
End Levee Mile	1.60
Location	Water Side
Category	Earthen Levee
Item	Vegetation
This photo shown here was listed with a U rating. The waterside is completely overgrown from shoulder to beyond waterside toe. The crown has weeds 2-feet tall.	
phillips_s_20120306_331.jpg

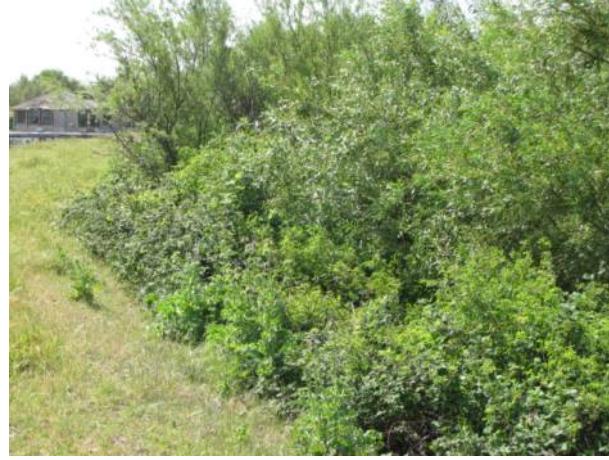
Levee Mile Report Line	24
Start Levee Mile	1.43
End Levee Mile	1.60
Location	Water Side
Category	Earthen Levee
Item	Vegetation
Overgrown shoulder and slope. Photo taken 5-2-2012.	
phillips_s_20120525_480.jpg

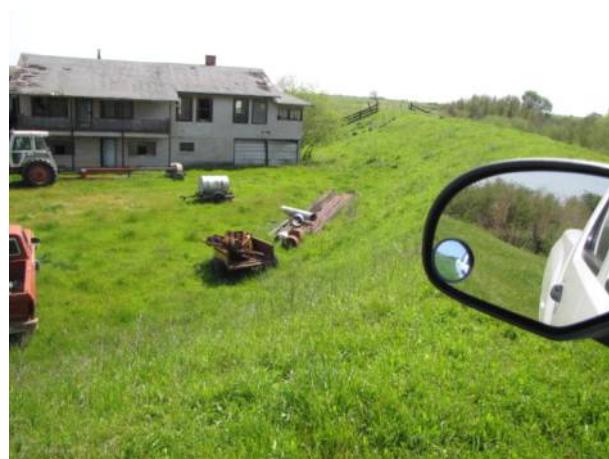
Levee Mile Report Line	27
Start Levee Mile	1.64
End Levee Mile	1.64
Location	Land Side
Category	Earthen Levee
Item	Encroachments
Looking at the material within 10-foot of landward toe levee mile 1.64 RD 2104. Photo taken 4-14-2011	
phillips_s_20120306_342.jpg

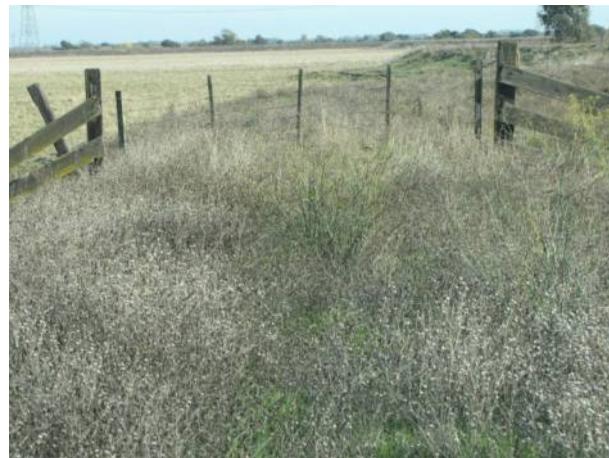
Levee Mile Report Line	28
Start Levee Mile	1.66
End Levee Mile	1.70
Location	Crown
Category	Earthen Levee
Item	Vegetation
Unsatisfactory wild growth on levee crown roadway. Photo taken 11-15-2011.	
phillips_s_20120306_345.jpg

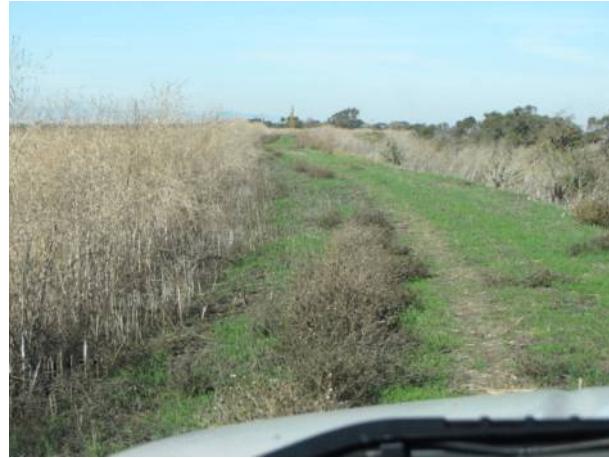
Levee Mile Report Line	29
Start Levee Mile	1.69
End Levee Mile	2.60
Location	Crown
Category	Earthen Levee
Item	Vegetation
Looking downstream from levee 1.69 to 2.60 crown has not been sterilized.	
phillips_s_20120306_337.jpg

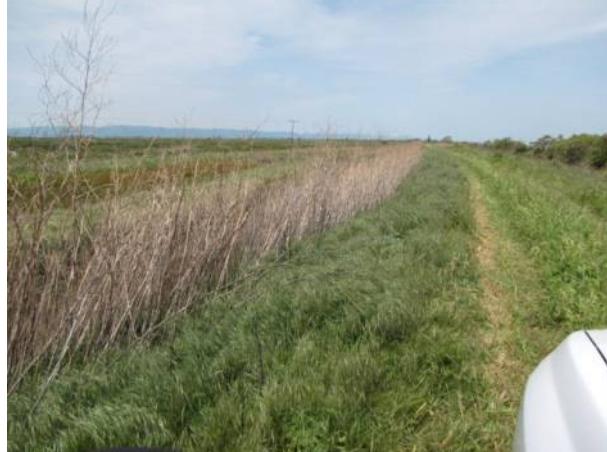
Levee Mile Report Line	36
Start Levee Mile	4.21
End Levee Mile	4.70
Location	Land Side
Category	Earthen Levee
Item	Vegetation
Looking downstream landside of RD 2104 Levee mile 4.21 unsatisfactory growth slopes and crown roadway. Photo taken 4-14-2011.	
phillips_s_20120306_340.jpg

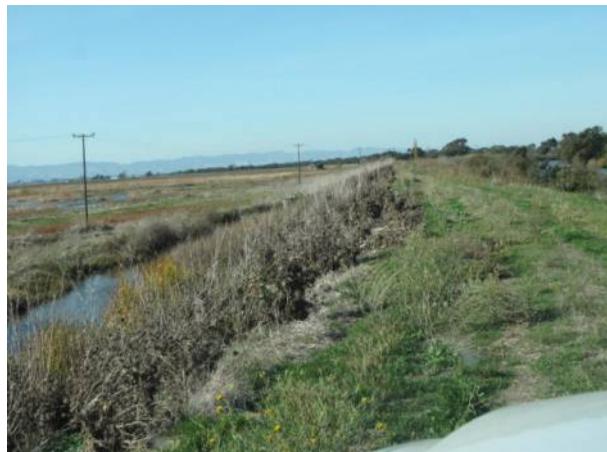
Levee Mile Report Line	36
Start Levee Mile	4.21
End Levee Mile	4.70
Location	Land Side
Category	Earthen Levee
Item	Vegetation
Levee mile 4.21-4.70. Photo taken 11-15-2011.	
phillips_s_20120306_341.jpg

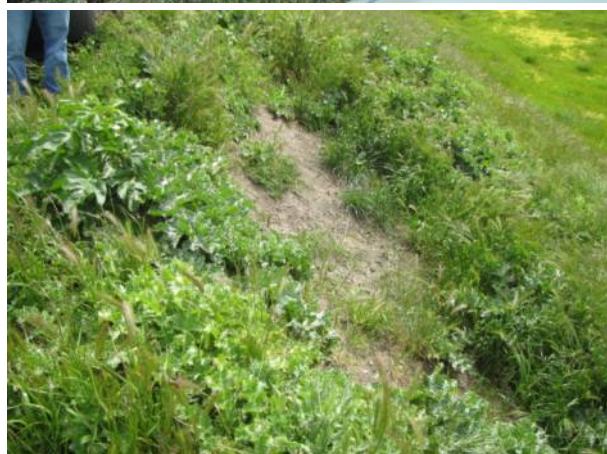
Levee Mile Report Line	38
Start Levee Mile	4.88
End Levee Mile	4.88
Location	Land Side
Category	Earthen Levee
Item	Erosion / Bank Caving
Erosion noted at levee mile 4.88 made by livestock along landside slope. Photo taken 4-14-2011.	
phillips_s_20120306_343.jpg

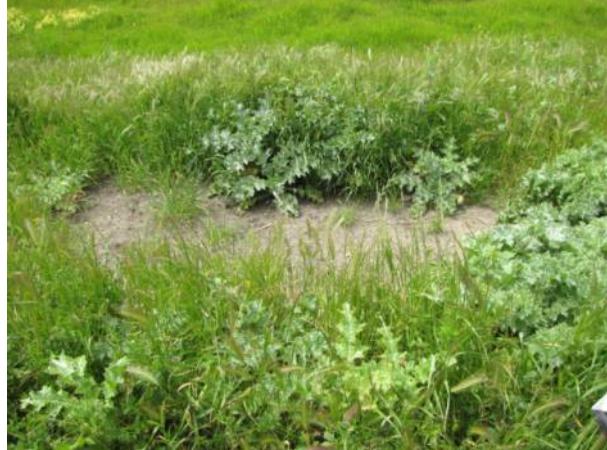
Levee Mile Report Line	39
Start Levee Mile	4.90
End Levee Mile	4.90
Location	Land Side
Category	Earthen Levee
Item	Erosion / Bank Caving
Erosion noted at levee mile 4.90 RD 2104 landside slope. Livestock caused this erosion. Photo taken 4-14-2011.	
phillips_s_20120306_344.jpg

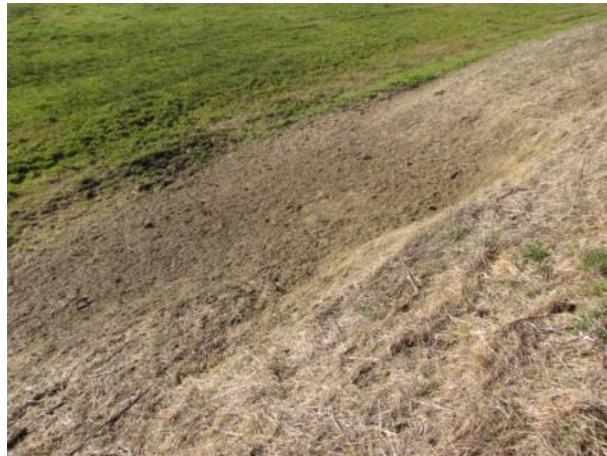
Levee Mile Report Line	40
Start Levee Mile	5.03
End Levee Mile	5.03
Location	Land Side
Category	Earthen Levee
Item	Erosion / Bank Caving
Erosion done by live stock (bulls) on levee section at this location. Photo taken 11-15-2011.	
phillips_s_20120306_347.jpg
